1. STATE Connecticut COUNTY Hartford TOWN E. Hartford VICINITY STREET NO. Main St. and Connecticut Boulevard ORIGINAL OWNER First Congregational ORIGINAL USE Church PRESENT OWNER Church PRESENT USE Church WALL CONSTRUCTION Frame NO. OF STORIES		HISTORIC AMERICAN BUILDINGS SURVEY INVENTORY

2. NAME First Congregational Church DATE OR PERIOD c. 1835 STYLE Greek Revival ARCHITECT Third edifice since 1699 BUILDER	
		3. FOR LIBRARY OF CONGRESS USE

1. STATE Connecticut COUNTY Hartford TOWN E. Hartford VICINITY STREET NO. 135 Forbes Street ORIGINAL OWNER James Forbes ORIGINAL USE PRESENT OWNER James Forbes PRESENT USE House WALL CONSTRUCTION Frame, clapboard NO. OF STORIES 2 1/2		HISTORIC AMERICAN BUILDINGS SURVEY INVENTORY

2. NAME James S. Forbes house DATE OR PERIOD 1765 STYLE ARCHITECT BUILDER	
		3. FOR LIBRARY OF CONGRESS USE	
4. NOTABLE FEATURES, HISTORICAL SIGNIFICANCE AND DESCRIPTION <div style="text-align: right;">OPEN TO PUBLIC No</div> <p>House is reputed to have stored kegs of silver to pay French soldiers during Revolution, giving name to street known as Silver Lane. Still in Forbes family, members of whom provided information about interior, which has been considerably alte

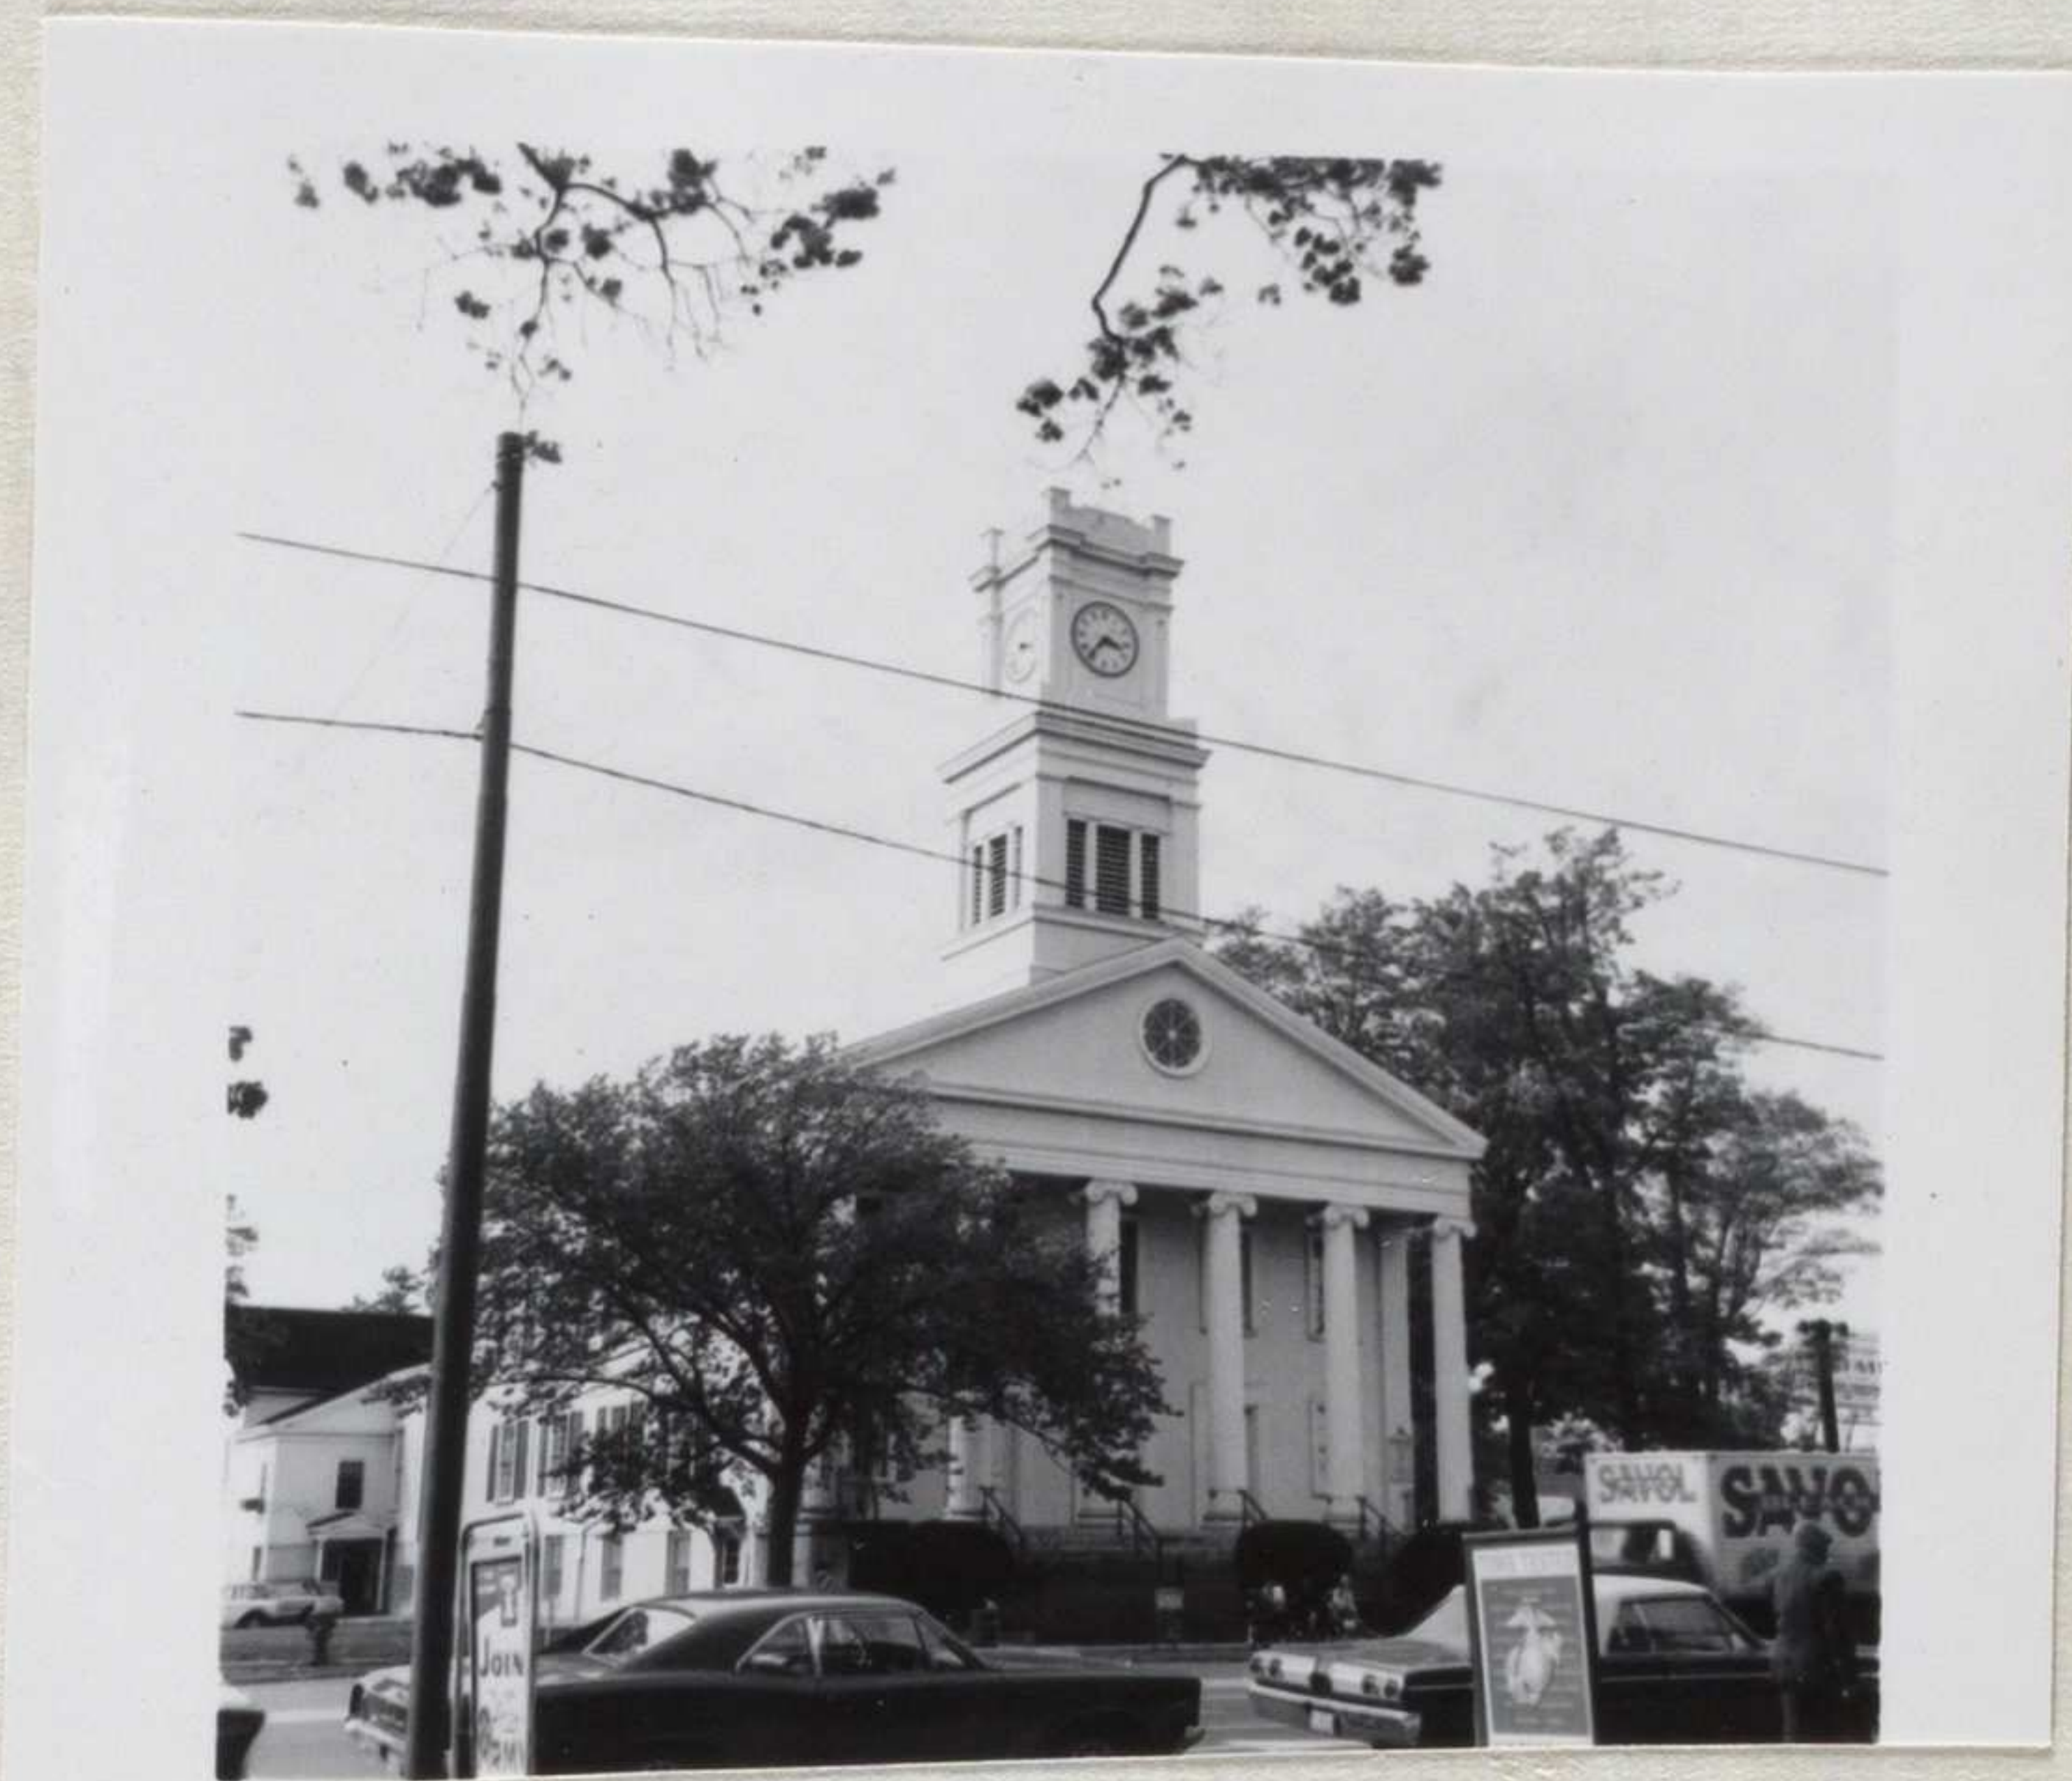
5. PHYSICAL CONDITION OF STRUCTURE Endangered No Interior DNS Exterior			
Main St. and Connecticut Boulevard			
6. LOCATION MAP (Plan Optional)		7. PHOTOGRAPH D-4

4. NOTABLE FEATURES, HISTORICAL SIGNIFICANCE AND DESCRIPTION <div>Large and imposing structure of its type and period, on brick basement with porch of dressed stone. Six large Ionic columns across front are now on cast concrete bases. Entrances of three large double doors with deep-set panels and very plain, rather awkward door frames matching similar window frames are replacements of sheet metal. Exterior in general has been completely redone in recent past, with metal siding, very insensitively.</div> <div>

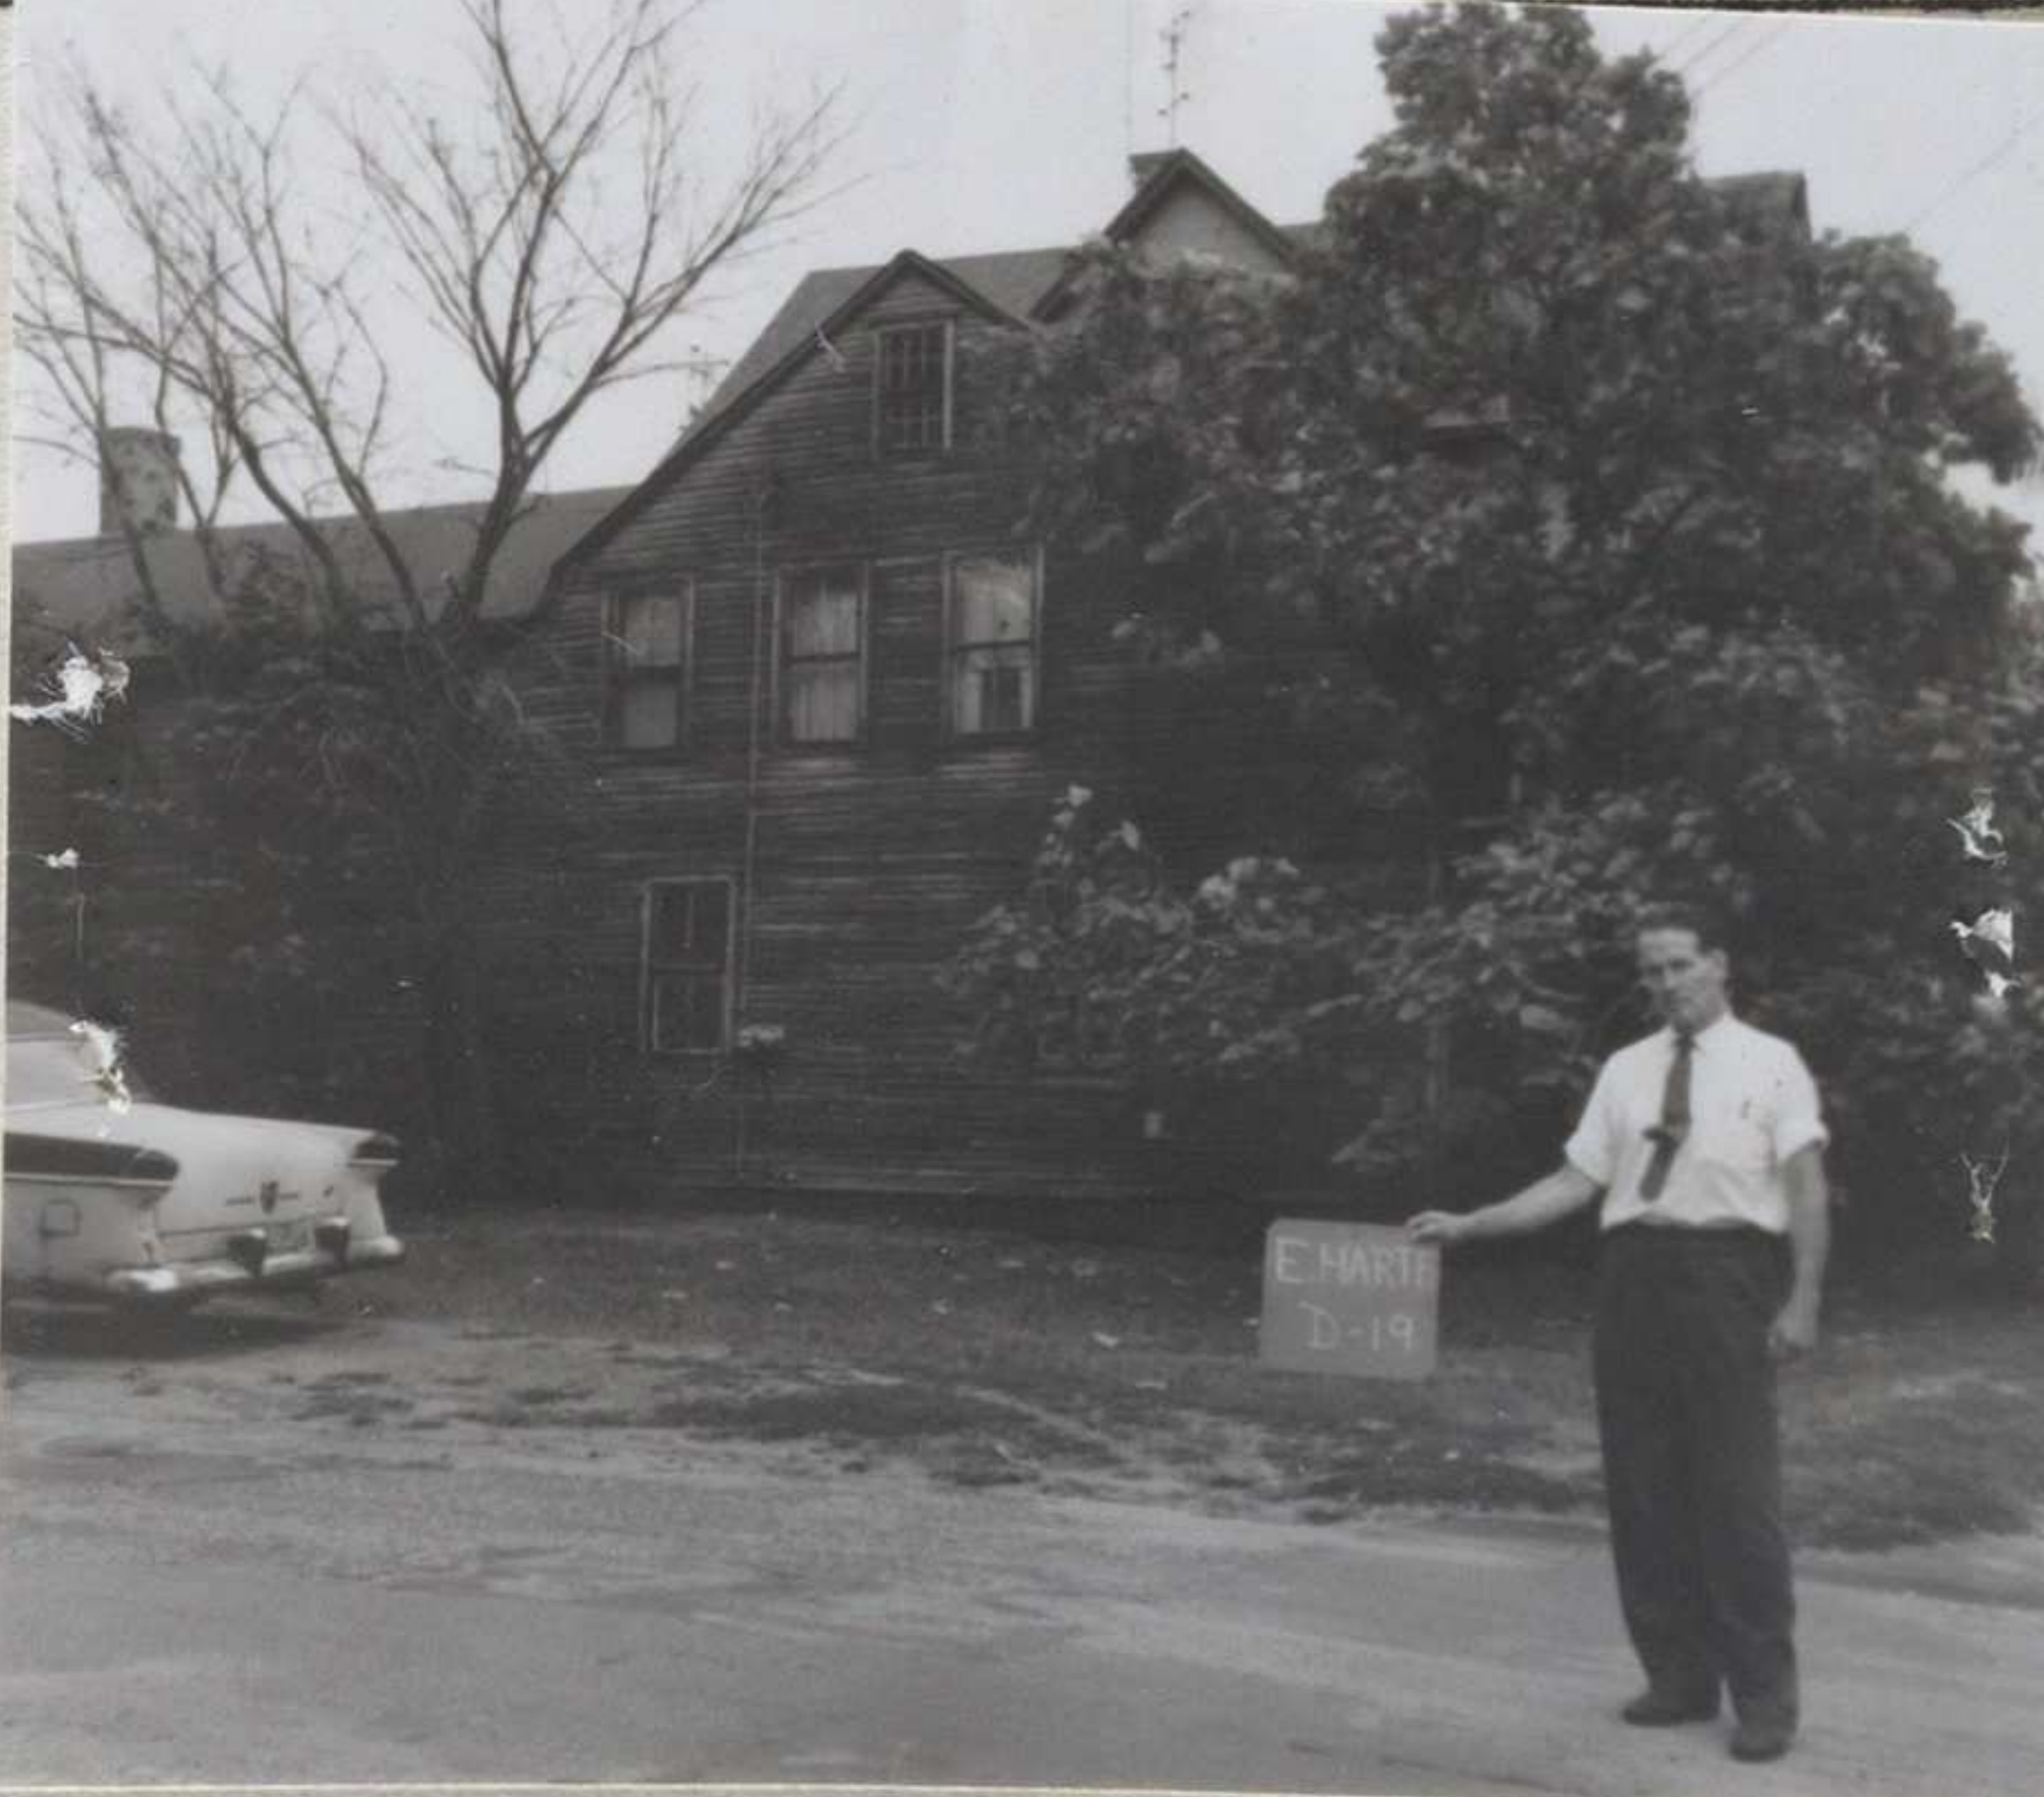
<p>1. STATE Connecticut COUNTY Hartford TOWN East Hartford VICINITY STREET NO. 126 Burnside Ave. Northeast corner of Burnside ORIGINAL OWNER & Clune Court ORIGINAL USE House PRESENT OWNER PRESENT USE House WALL CONSTRUCTION Frame, clapboard NO. OF STORIES 2</p>	<p>HISTORIC AMERICAN BUILDINGS SURVEY INVENTORY</p> <p>2. NAME Huguenot House</p> <p>DATE OR PERIOD STYLE ARCHITECT BUILDER</p> <p>3. FOR LIBRARY OF CONGRESS USE</p>
<p>4. NOTABLE FEATURES, HISTORICAL SIGNIFICANCE AND DESCRIPTION</p> <p>OPEN TO PUBLIC No</p> <p>A gambrel-roofed central chimney house apparently of first part of 18th century. Difficult to see or photograph because of surrounding heavy foliage. Clapboards appear original or at least very old, largely fastened with hand-wrought nails. Long rear wing probably a later addition, Since clapboards are much wider and point of junction to main house is very evident. All sash of main house except attic and dormers (9 over 6) are later 2 over 2 type. Attic sash is 6 over 6. Present inhabitants not of a kind to give much care to building, which deserves preservation for its architecture, age, and amount of original material on exterior at least. Foundation is dressed sandstone. Oil delivery man (Hudson Oil Co.) said owner's wife died about 6 months ago and owner is now alone and old. May indicate some action respecting house in near future.</p> <p>Demolished as of 1976 Survey - J.R.</p>

<p>5. PHYSICAL CONDITION OF STRUCTURE</p> <p>126 Burnside Avenue Northeast corner of Burnside and Clune Court.</p>	<p>Endangered Yes Interior DNS Exterior Poor</p>

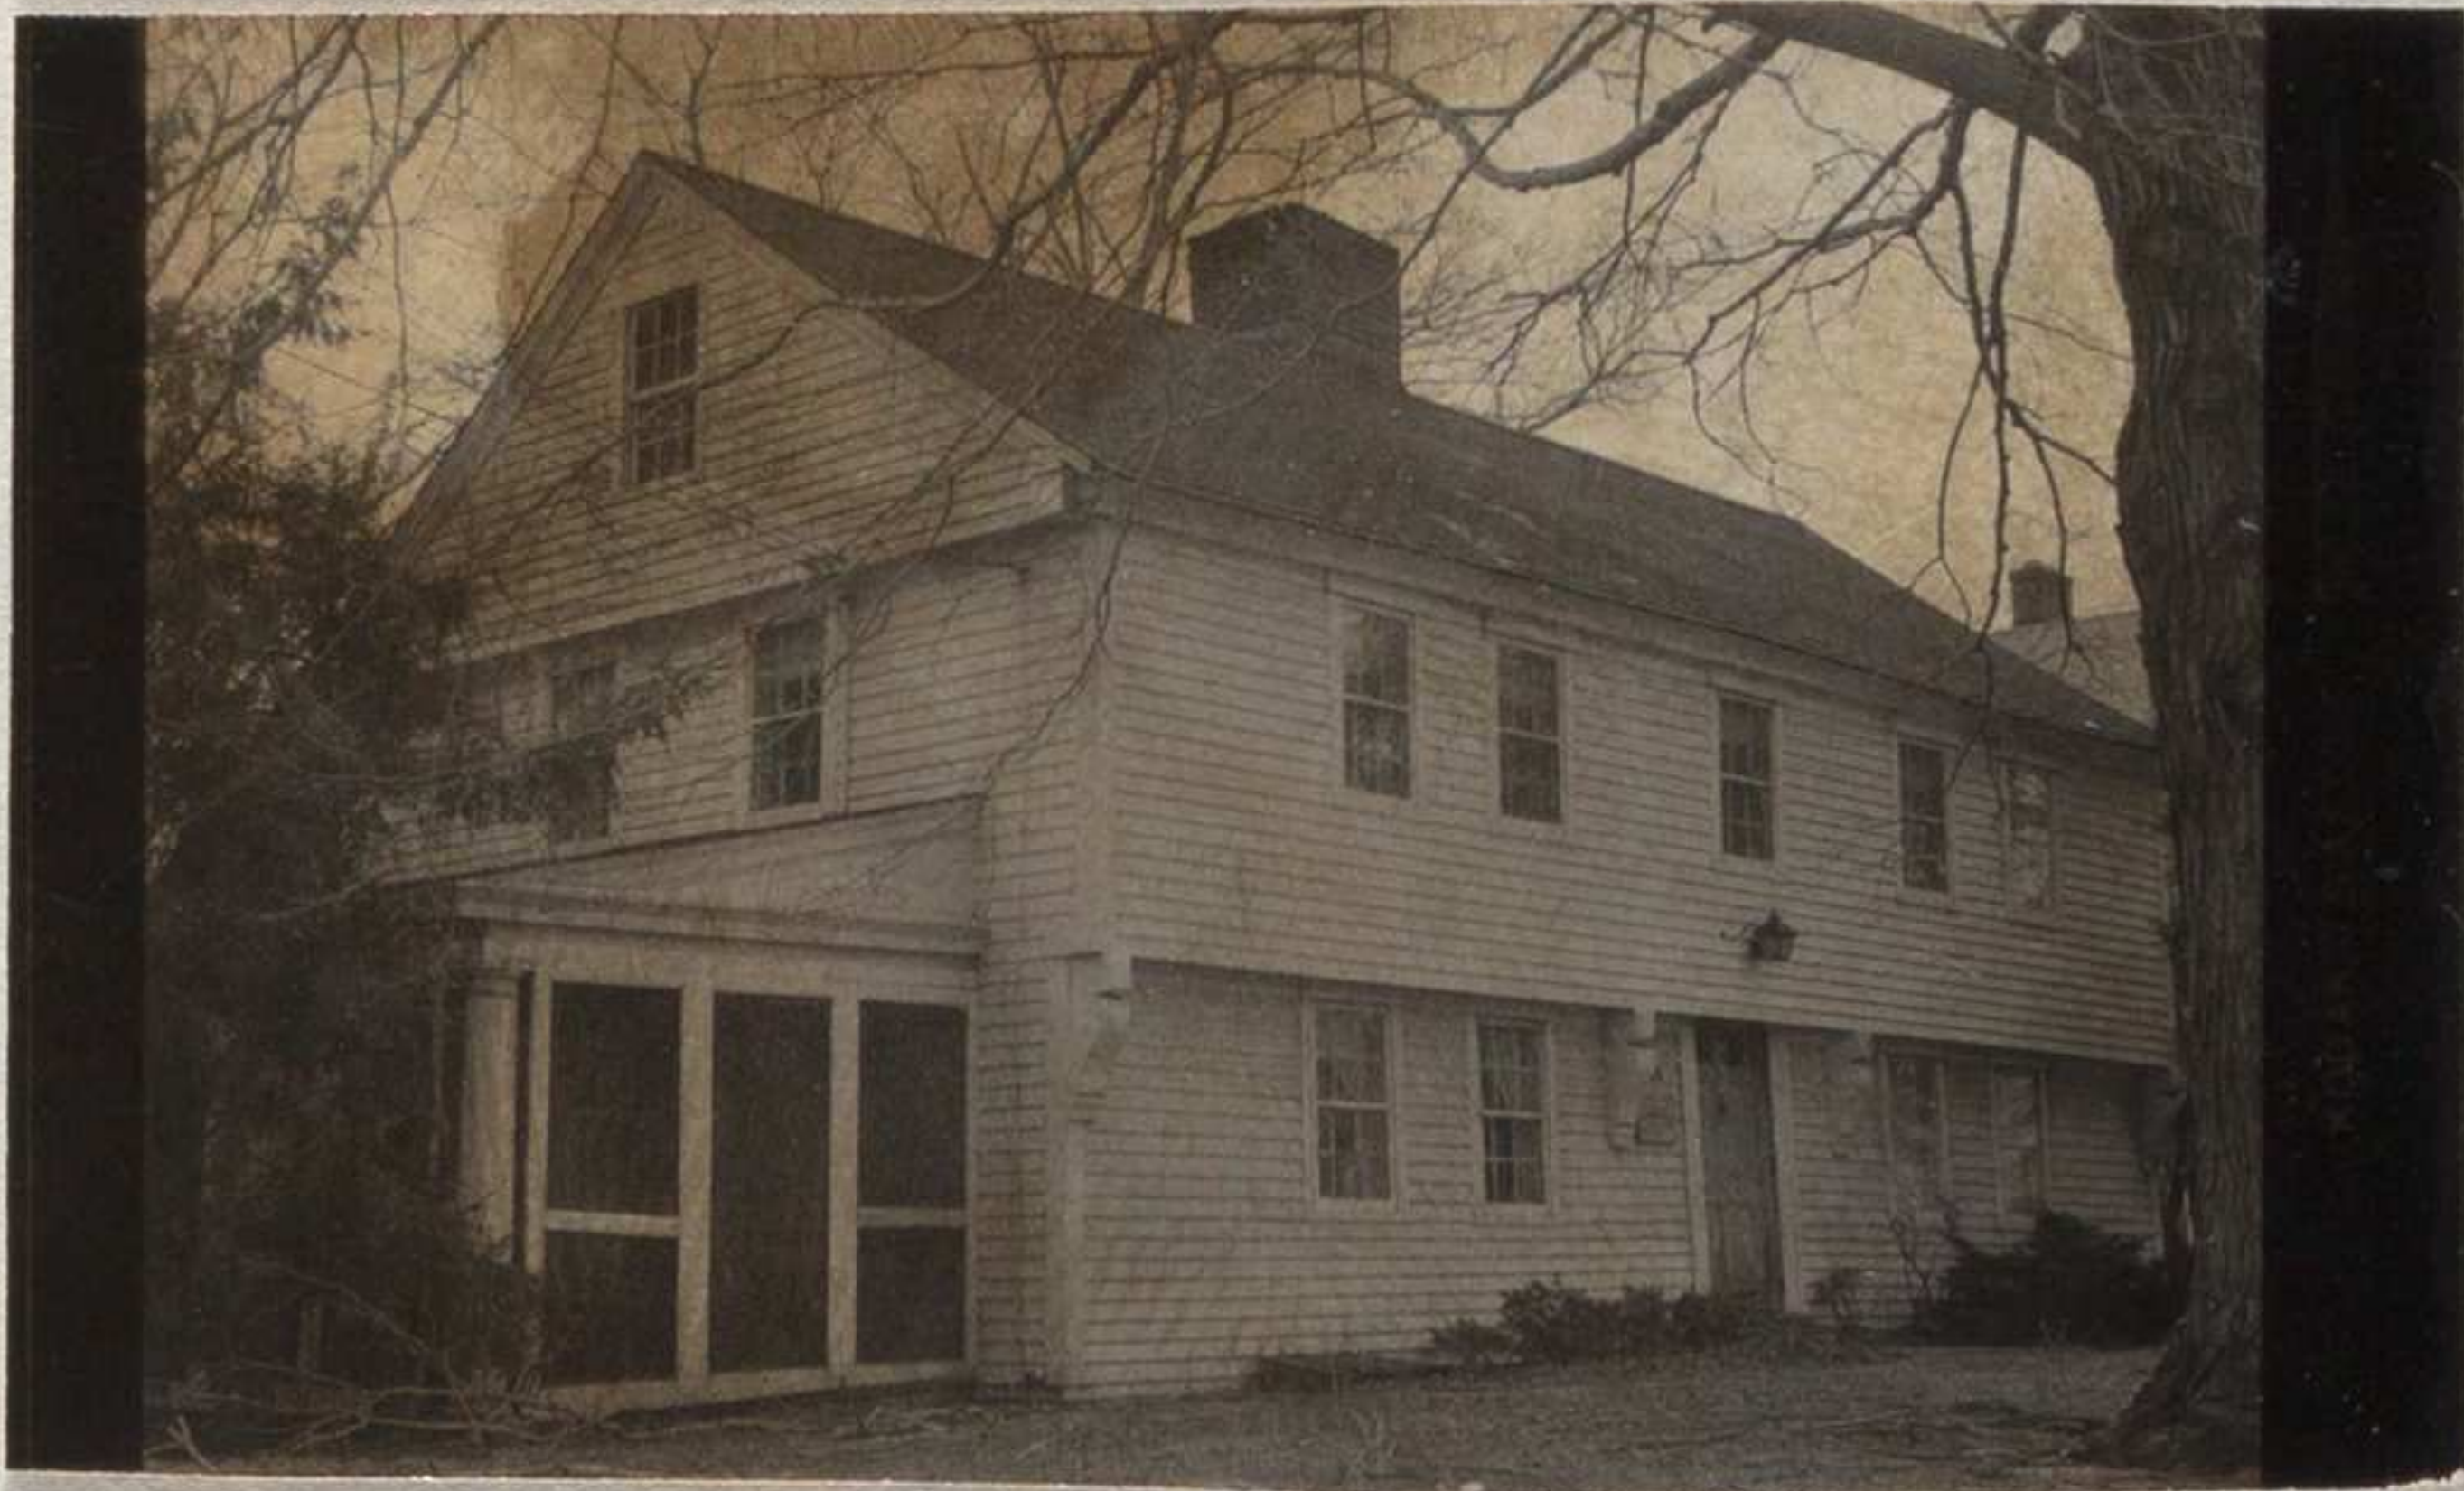
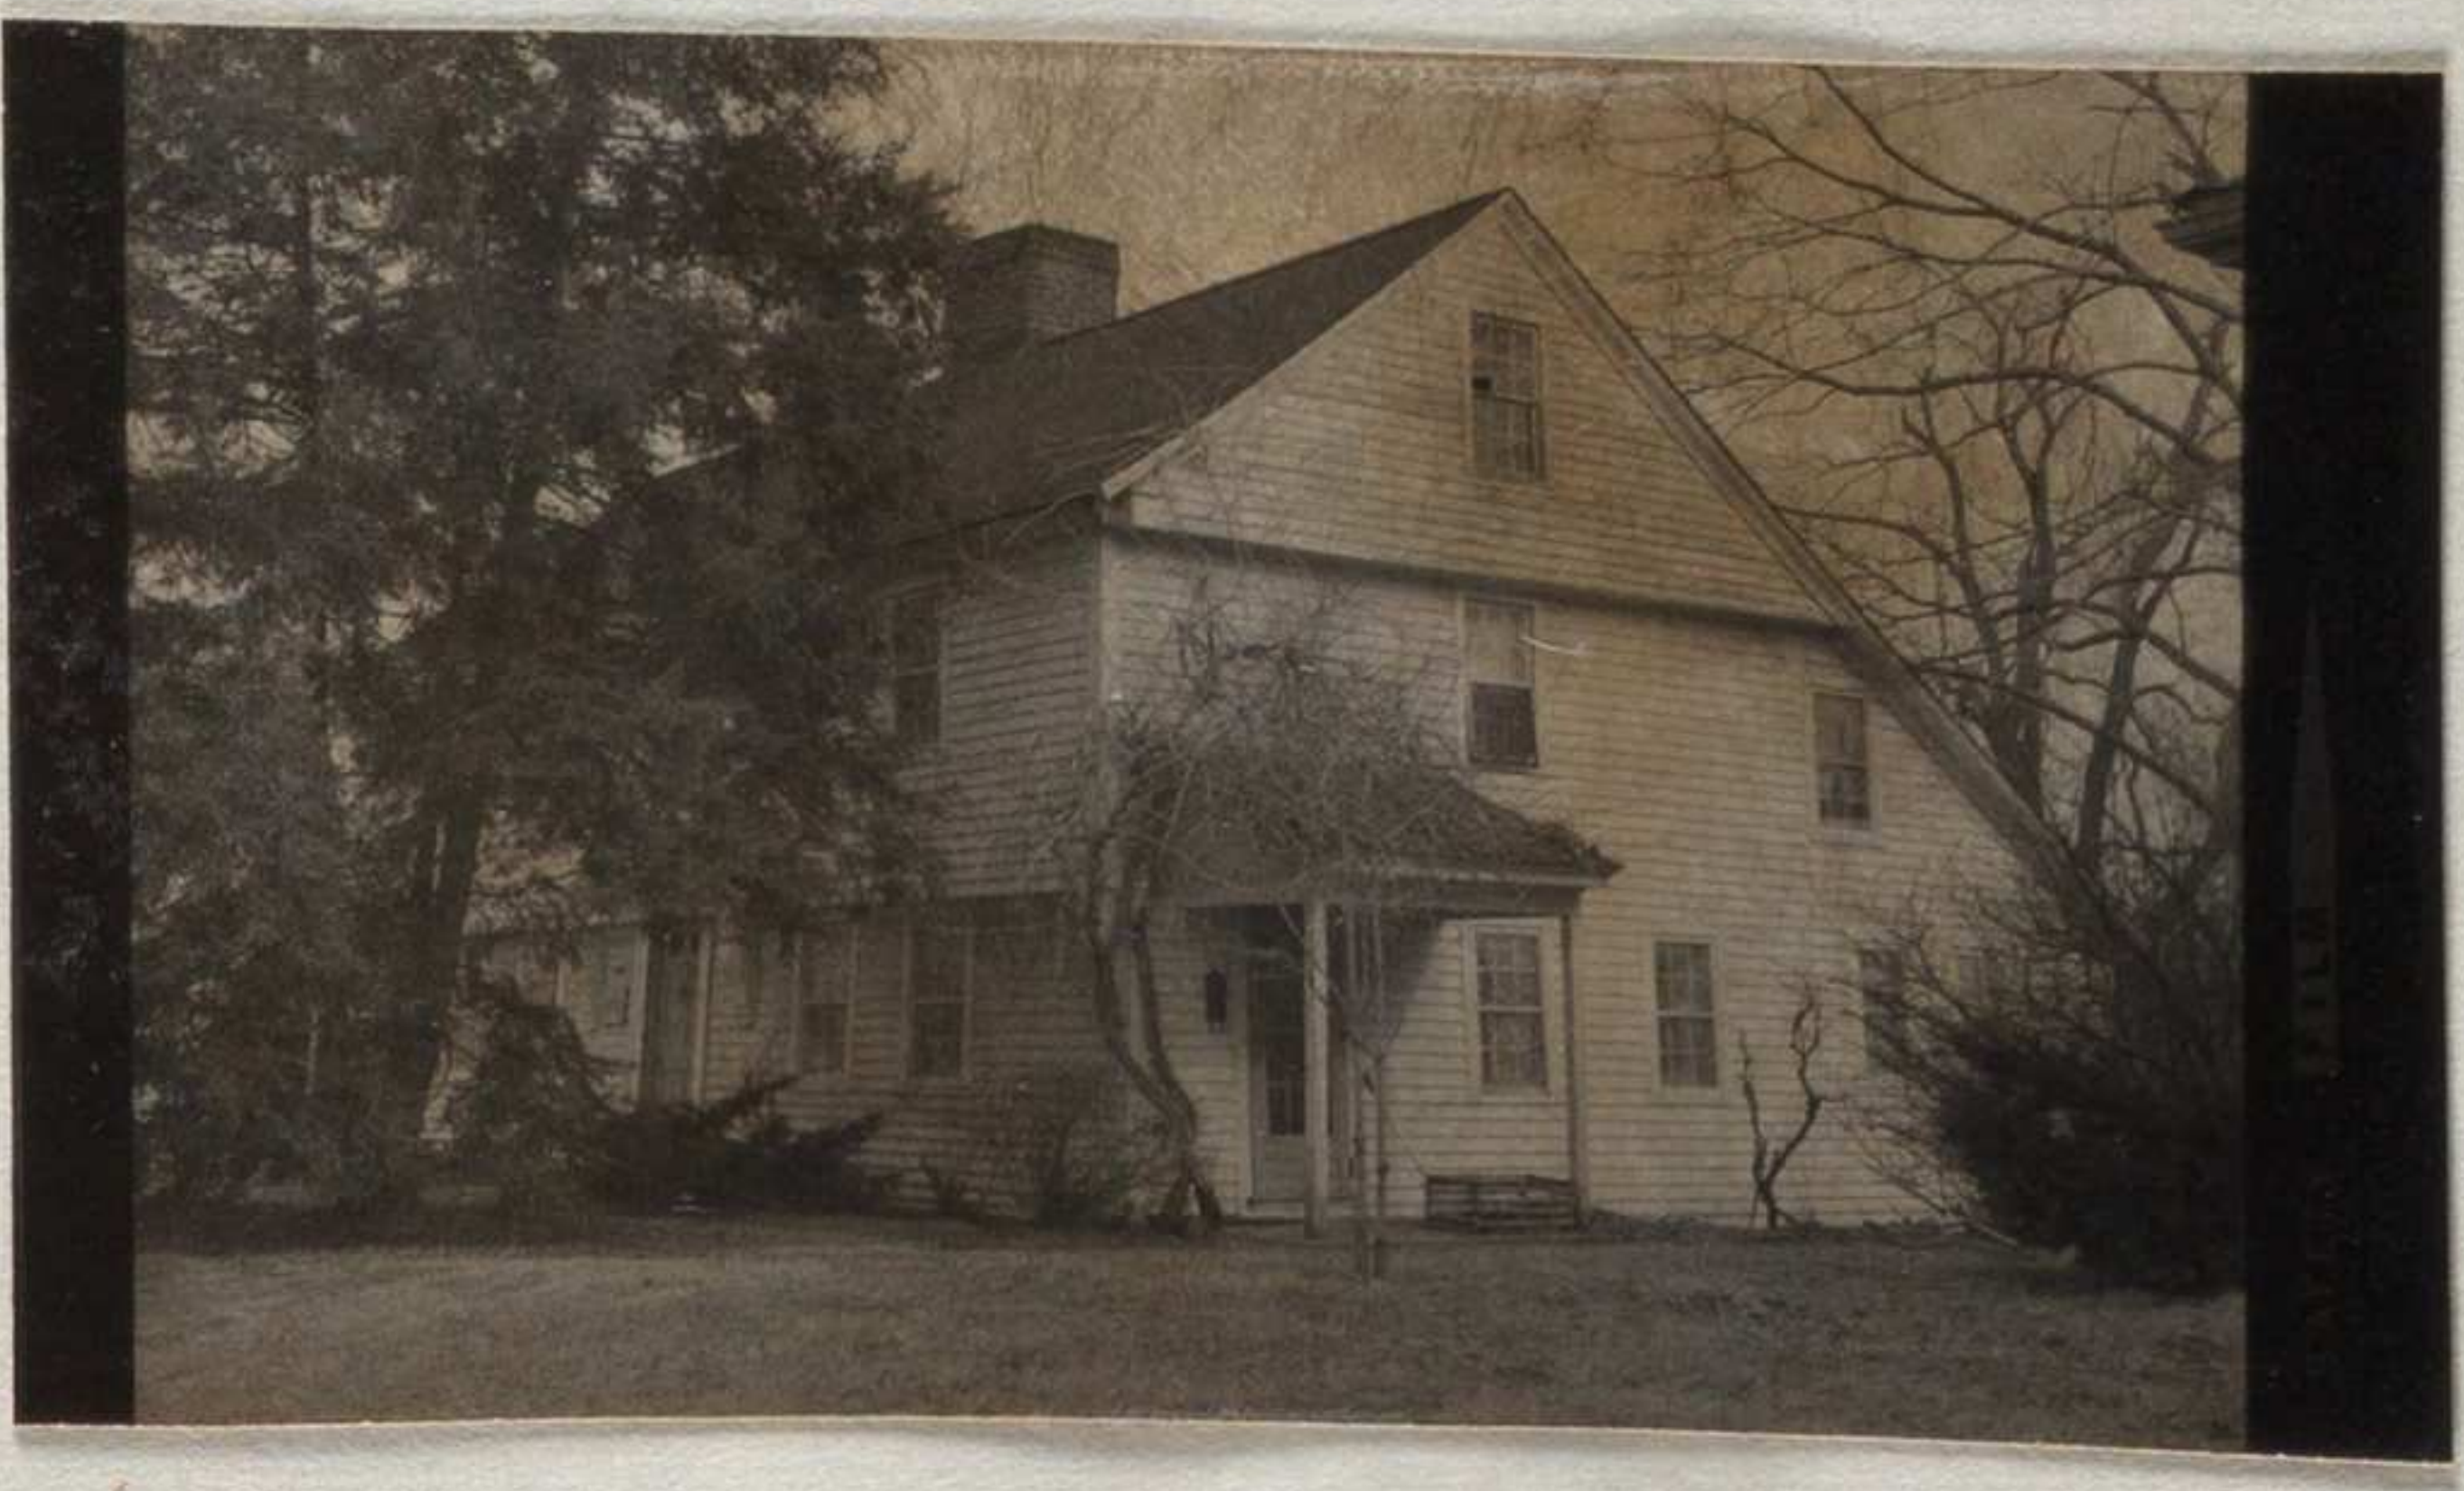
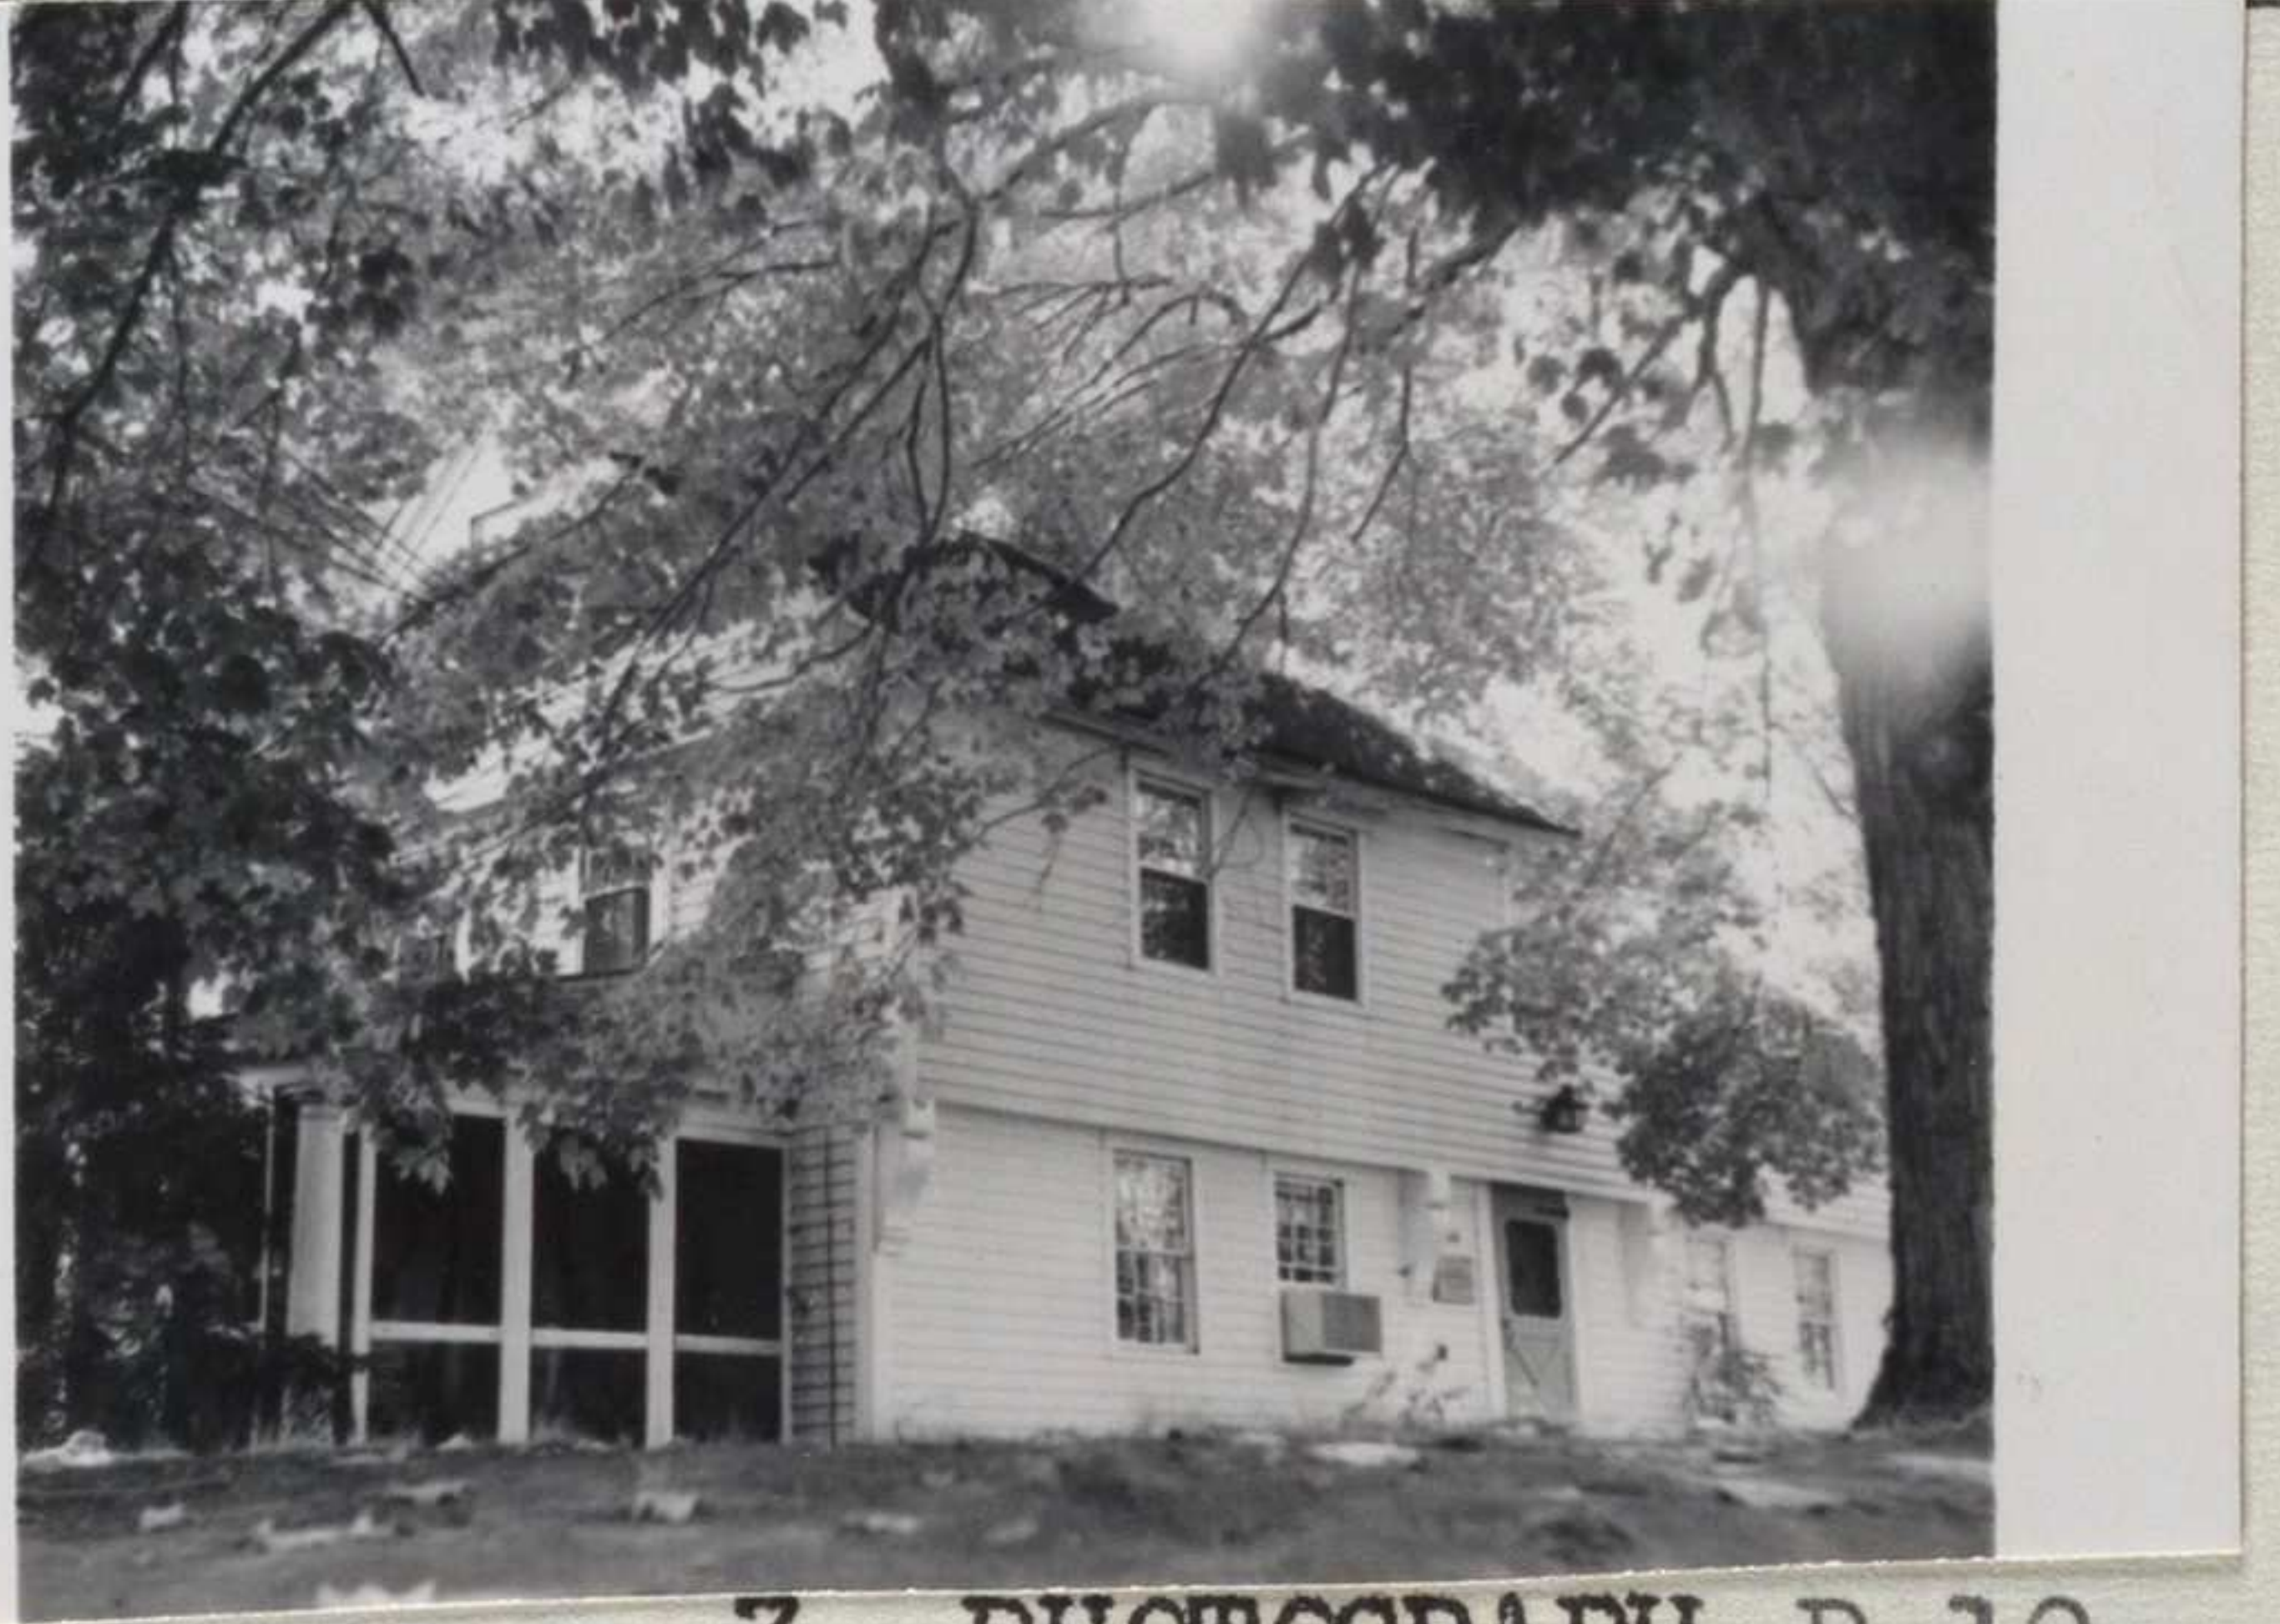
6. LOCATION MAP (Plan Optional)		7. PHOTOGRAPH D-10

2. NAME Old George Risley House DATE OR PERIOD About 1690 (sign on house) STYLE ARCHITECT BUILDER	
		3. FOR LIBRARY OF CONGRESS USE	
4. NOTABLE FEATURES, HISTORICAL SIGNIFICANCE AND DESCRIPTION OPEN TO PUBLIC No A lean-to or saltbox type with about a 9 inch overhang across front at first floor ceiling level, four brackets beneath. These appear to be restorations, as does all exterior woodwork. Overhang also in gable ends at second floor ceiling level. All sash have been replaced. Added porch sheltering entry door at south end of house, which faces west. Added screened porch with wooden Doric columns at north side. Central chimney also appears replaced above roof. Small chimney added at rear. Composition shingles.

5. PHYSICAL CONDITION OF STRUCTURE Endangered No Interior DNS Exterior Good			
236 High Street, southeast corner of Wadsworth Street.
