1. STATE Connecticut COUNTY Hartford TOWN E. Hartford VICINITY STREET NO. Main St. and Connecticut Boulevard ORIGINAL OWNER First Congregational ORIGINAL USE Church PRESENT OWNER Church PRESENT USE Church WALL CONSTRUCTION Frame NO. OF STORIES		HISTORIC AMERICAN BUILDINGS SURVEY INVENTORY

2. NAME First Congregational Church DATE OR PERIOD c. 1835 STYLE Greek Revival ARCHITECT Third edifice since 1699 BUILDER	
		3. FOR LIBRARY OF CONGRESS USE

1. STATE Connecticut COUNTY Hartford TOWN E. Hartford VICINITY STREET NO. 135 Forbes Street ORIGINAL OWNER James Forbes ORIGINAL USE PRESENT OWNER James Forbes PRESENT USE House WALL CONSTRUCTION Frame, clapboard NO. OF STORIES 2 1/2		HISTORIC AMERICAN BUILDINGS SURVEY INVENTORY

2. NAME James S. Forbes house DATE OR PERIOD 1765 STYLE ARCHITECT BUILDER	
		3. FOR LIBRARY OF CONGRESS USE	
4. NOTABLE FEATURES, HISTORICAL SIGNIFICANCE AND DESCRIPTION <div style="text-align: right;">OPEN TO PUBLIC No</div> <p>House is reputed to have stored kegs of silver to pay French soldiers during Revolution, giving name to street known as Silver Lane. Still in Forbes family, members of whom provided information about interior, which has been considerably alte

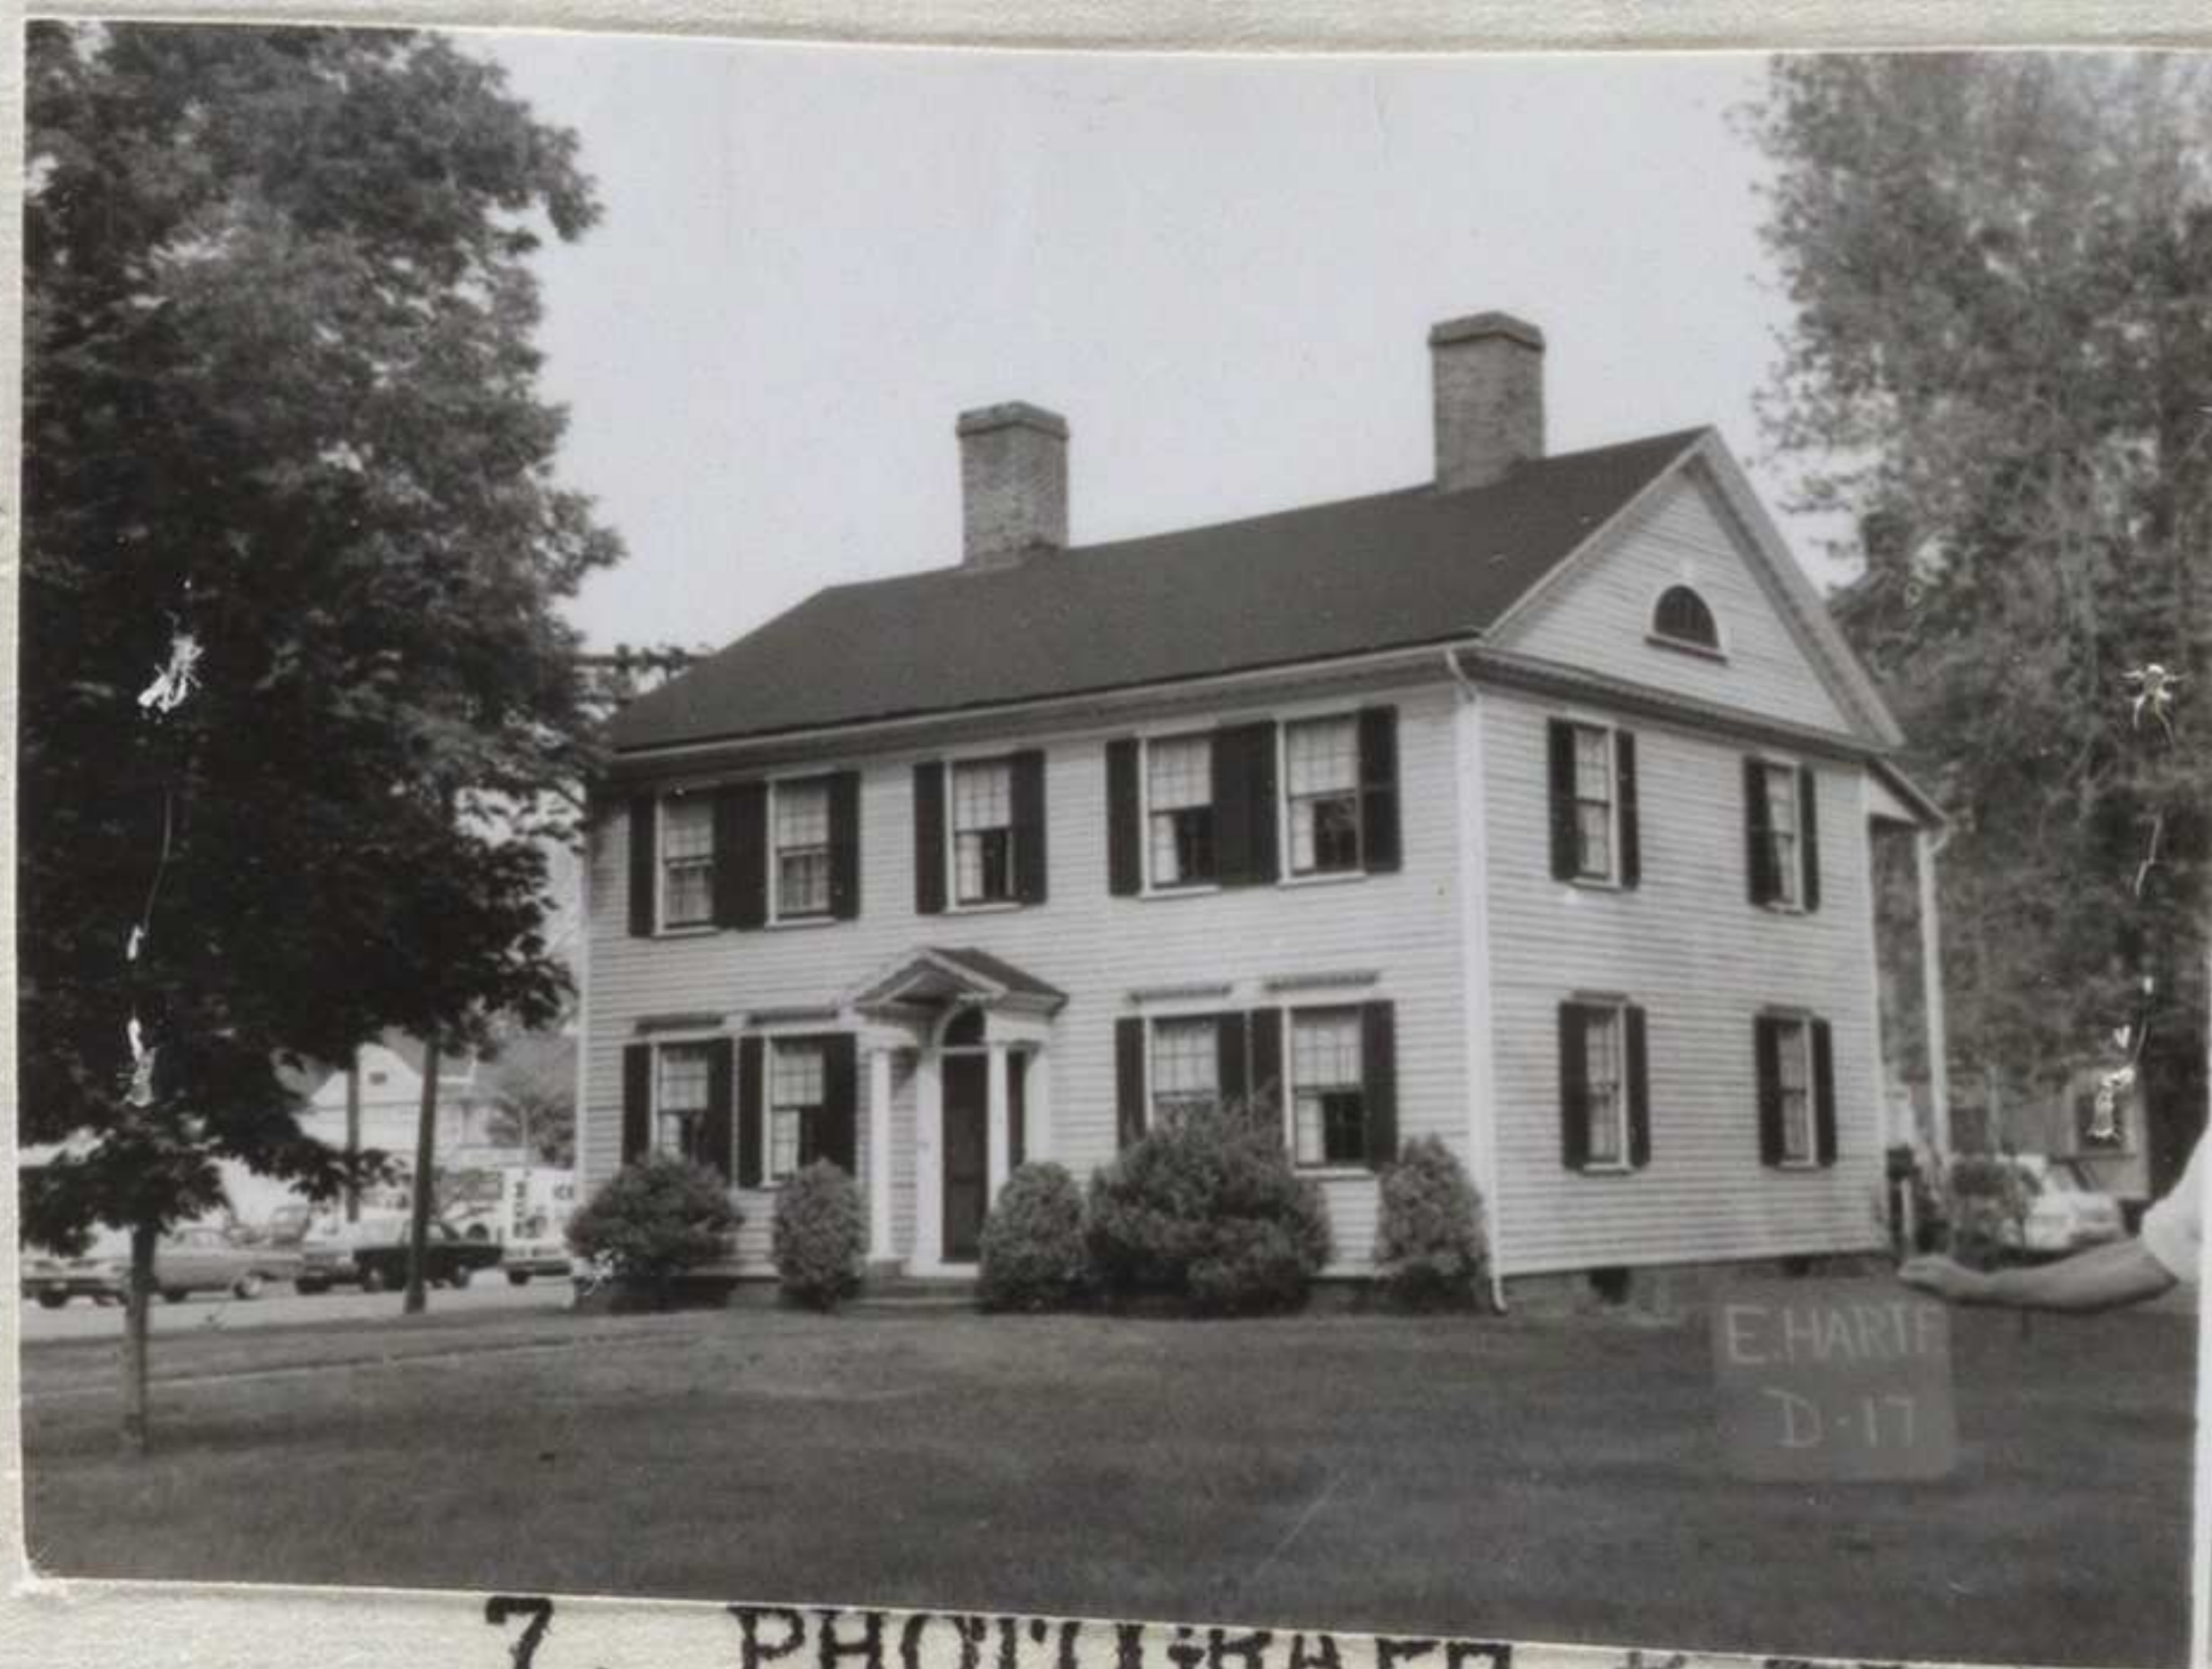
2. NAME DATE OR PERIOD 1785 - 1810 STYLE Federal ARCHITECT BUILDER	
		3. FOR LIBRARY OF CONGRESS USE	
4. NOTABLE FEATURES, HISTORICAL SIGNIFICANCE AND DESCRIPTION OPEN TO PUBLIC Modillion block cornice and heavy rope moulding. Auger hole hole decoration in both cornice and matching window caps in front of lower windows. Entrance portico - repeats fine decorative elements and shows frieze with triglyphs and metopes above Doric columns. Leaded fanlight. Keystone block in arch above fanlight. Foundation and entrance steps are dressed sandstone blocks. Tow chimney central hall type. <i>Demolished - spring 1970.</i>

5. PHYSICAL CONDITION OF STRUCTURE Endangered No Interior DNS Exterior Good			
1150 Main Street (corner Burnside Ave.)

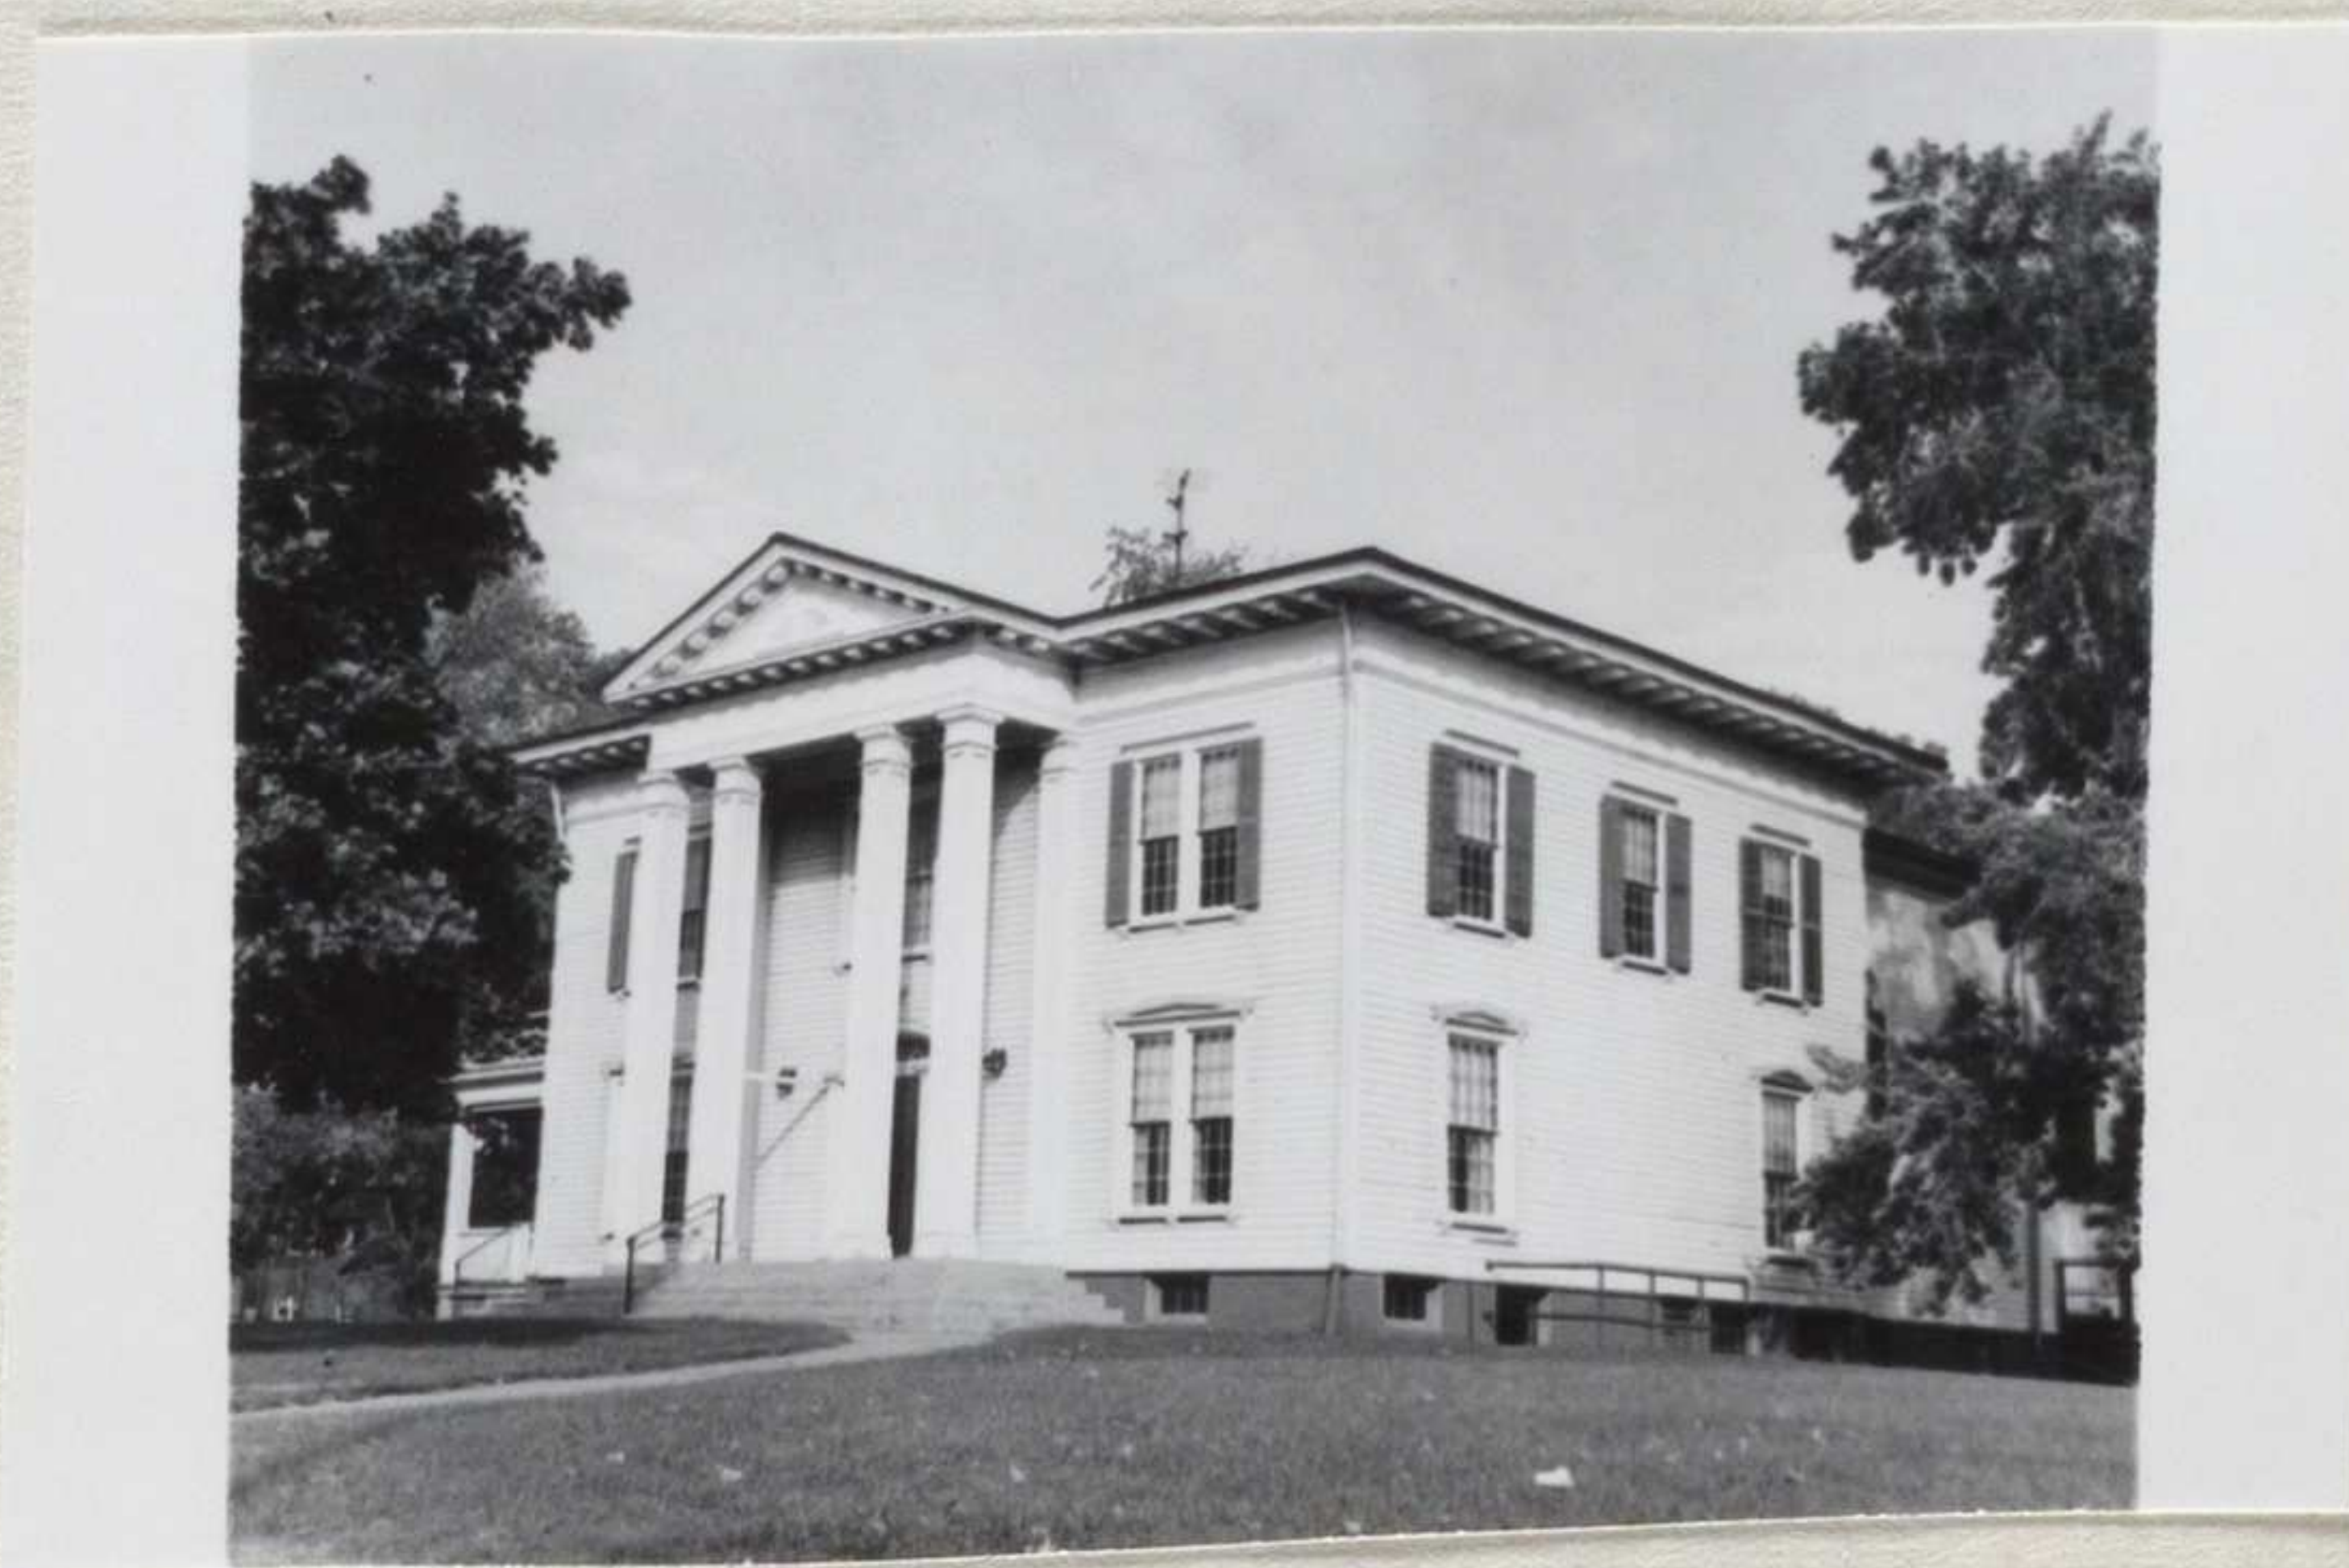
5. PHYSICAL CONDITION OF STRUCTURE Endangered No Interior DNS Exterior Good			
784 Main Street, southeast corner or Central Avenue			
6. LOCATION MAP (Plan Optional)		7. PHOTOGRAPH D-20

2. NAME <i>Greek Revival House</i> DATE OR PERIOD STYLE Greek Revival ARCHITECT BUILDER	
		3. FOR LIBRARY OF CONGRESS USE	
4. NOTABLE FEATURES, HISTORICAL SIGNIFICANCE AND DESCRIPTION <div style="text-align: right;">OPEN TO PUBLIC No</div> <p>Attractive proportioned building with entrance porch of 2-story height showing 4 square columns with paneled sides. fluted necks. Wide cornice all around of very simplified modillions. Leaded spider-wev fanlight over front door gives some distinction to entrance. Not an outstanding structure, but it lends character to its surroundings.</p> <div style="text-align: center;">

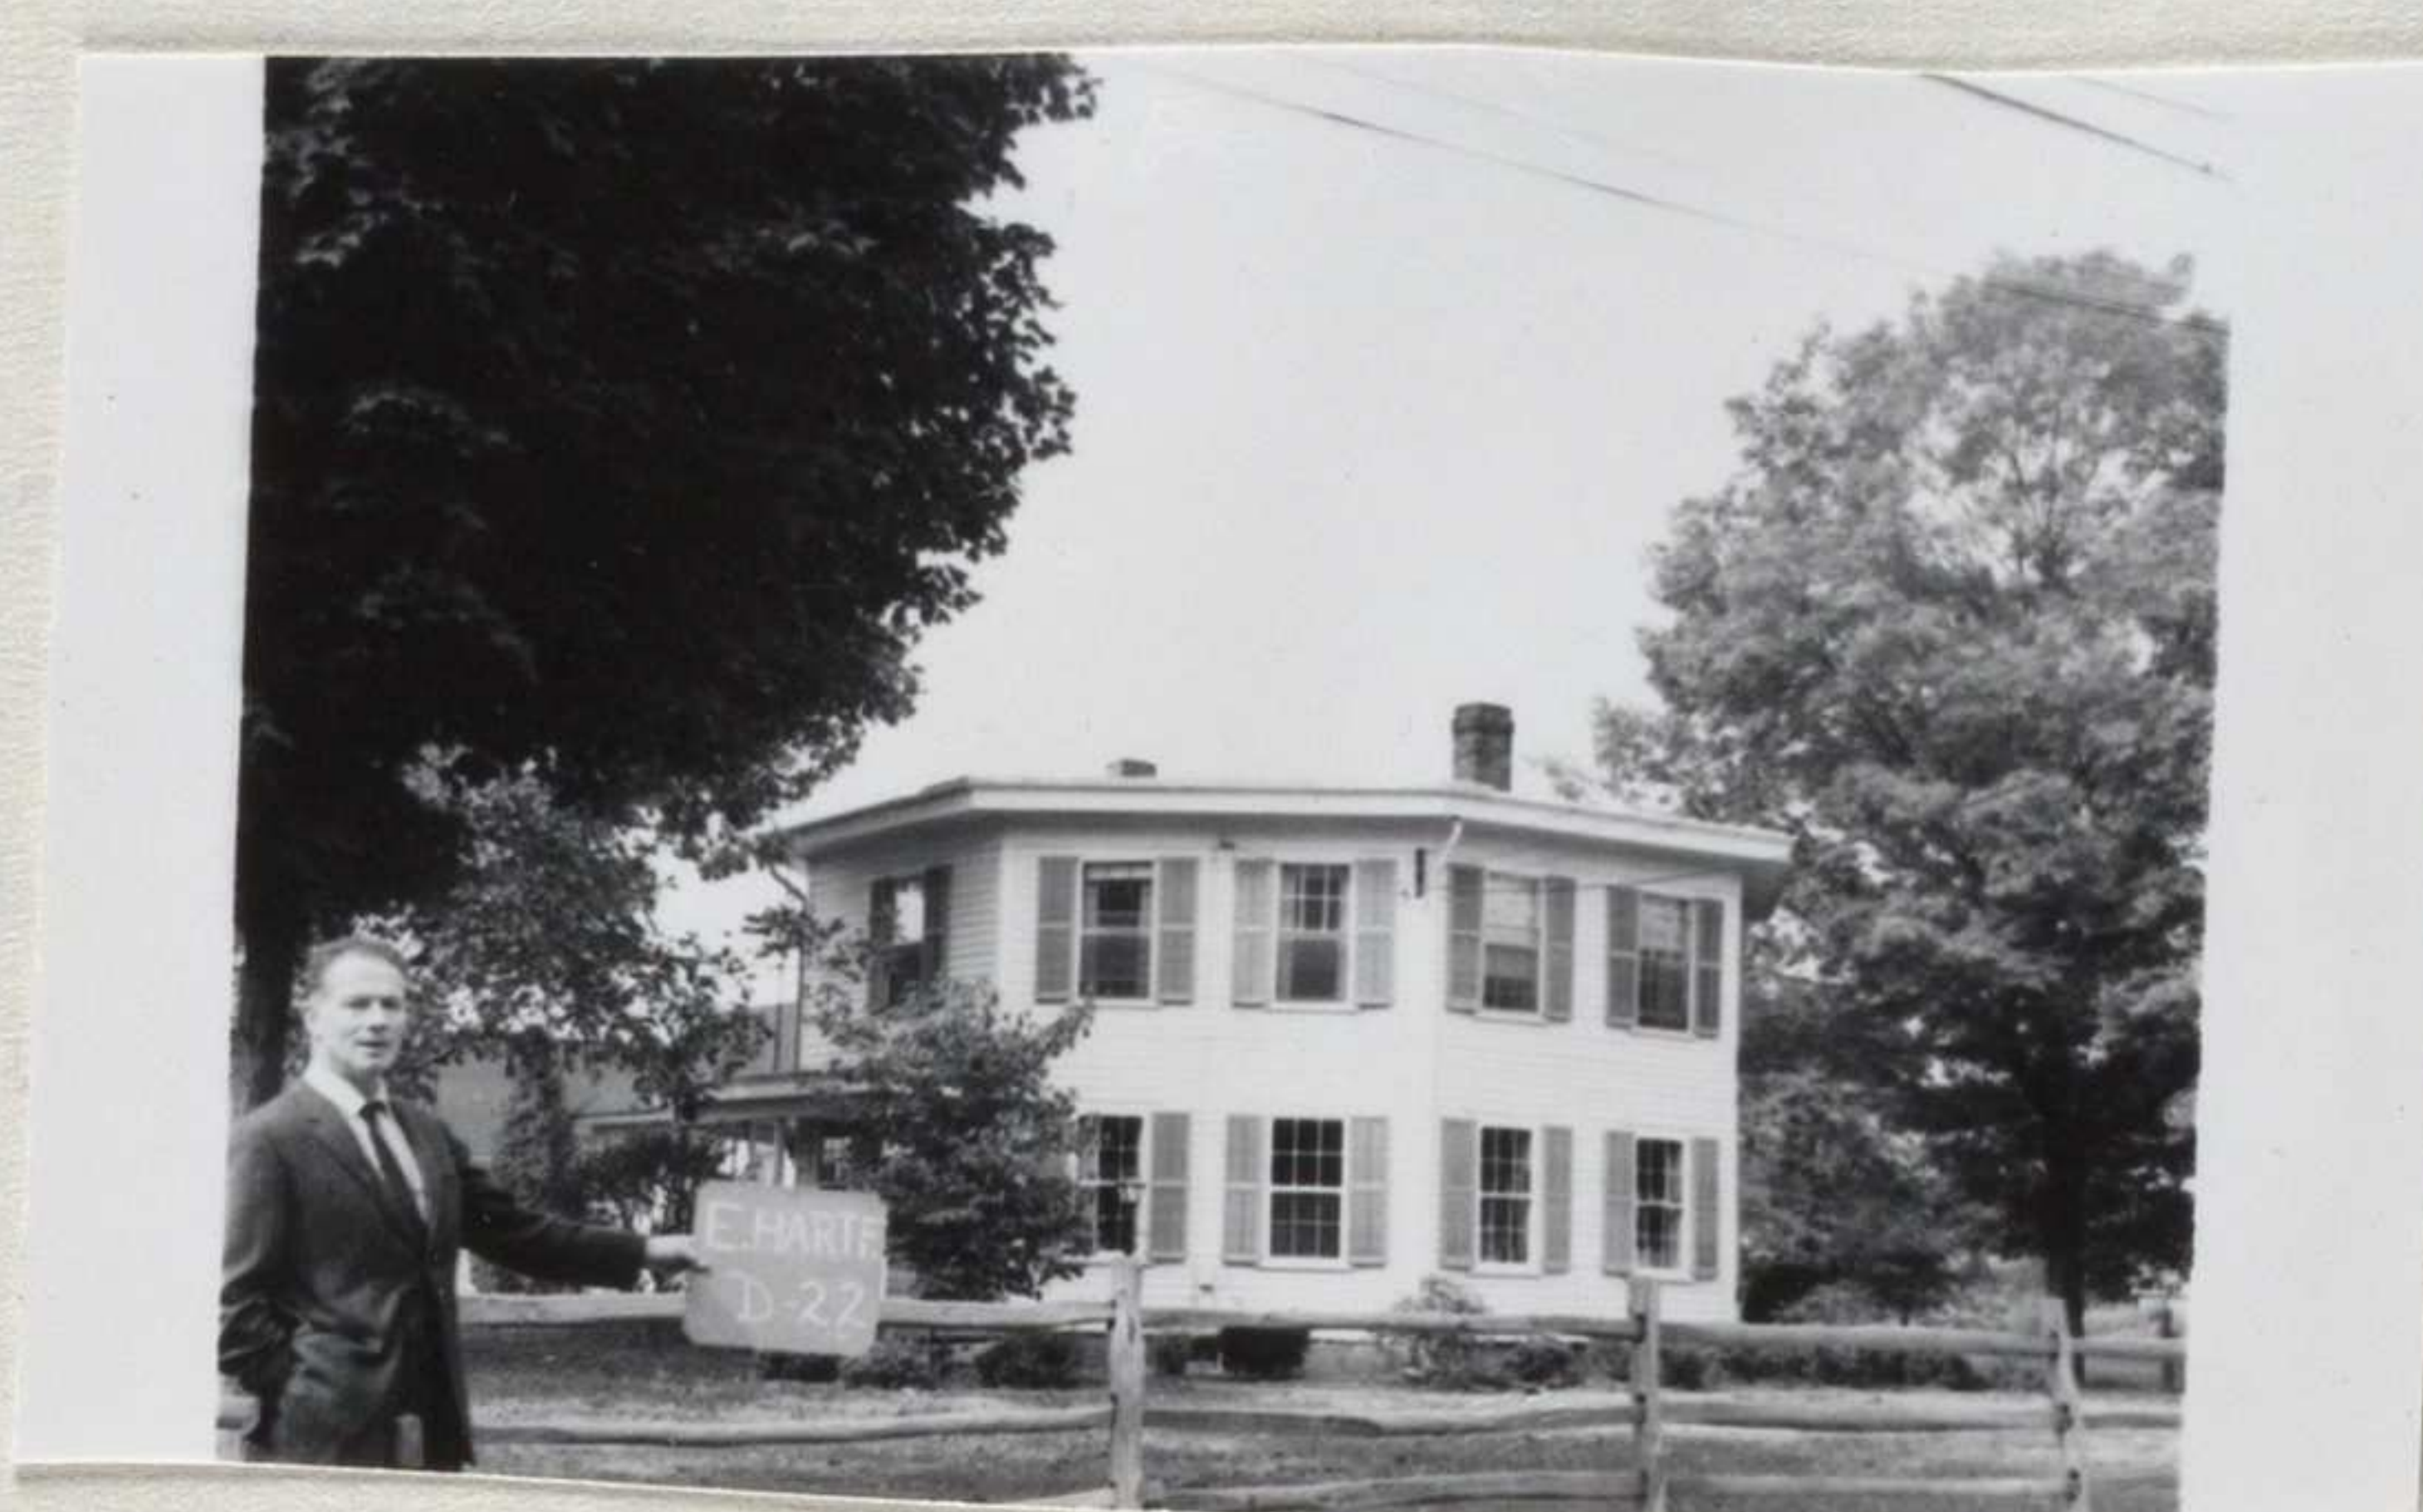
5. PHYSICAL CONDITION OF STRUCTURE		Endangered	Interior Exterior
159 Naubuc Ave. West side, between Broad St. and Colonial Lane			
6. LOCATION MAP (Plan Optional)		7. PHOTOGRAPH D-22

2. NAME Octagon DATE OR PERIOD Victorian STYLE Octagonal ARCHITECT BUILDER	
		3. FOR LIBRARY OF CONGRESS USE	
4. NOTABLE FEATURES, HISTORICAL SIGNIFICANCE AND DESCRIPTION			
OPEN TO PUBLIC No			
Small octagonal house with gable-roofed rear wing that may be later addition. Foundation is dressed graystone. That of wing is brick. Small entry porch on the side facing south. A very pleasing small-sized version of its architectural style and type.
